Time-lapse electrical resistivity monitoring of salt impacted soil and groundwater

Summary

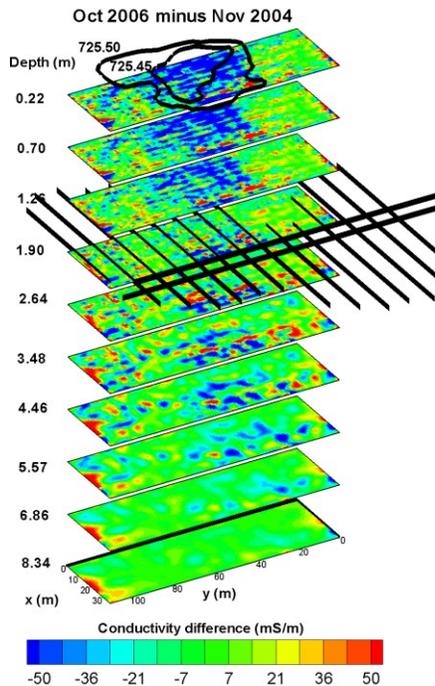
Figure 1: difference between October 2006 and November 2004 standard temperature equivalent images. Blue decrease in EC under the topography low and above the tile drains is interpreted to be due to flushing of salts.

The results of the ERI inversions appeared to capture the main features observed in the PTC logs, and a linear correlation with collocated core sample salinity measurements had an R^2 of 0.71. Difference images using standard temperature equivalent images show a decrease in EC above the tile drain lines under an enclosed topography low (Figure 1). Although the difference images contain many distortions due to noise, the decrease in EC was interpreted to be due to enhanced effectiveness of the tile drainage remediation system. This heightened effectiveness under the topography low is likely due to depression focused recharge. In order to use time-lapse inversion techniques to reduce ambiguity due to noise in the difference images, a temperature correction method that acts directly on the ERI data, instead than the inversion model, was developed. By performing the temperature correction on the data, the temperature correction is less affected by the smoothing in the inversion procedure, and time-lapse inversion techniques can be used on the temperature corrected data. A time-lapse inversion technique was developed that maximized the resolution of EC changes in a numerical test. These results produce clear images showing decreases in EC above the tile drainage system concentrated under a topography low (Figure 2).

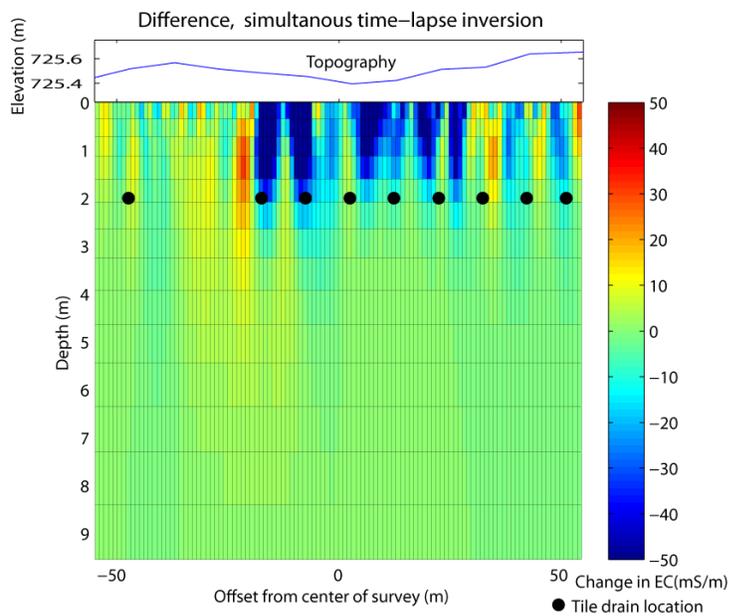
Figure 2: 2D time-lapse inversion of temperature compensated data from November 2004 and October 2006. EC decreases above the tile drains below the topography low are clearly present and interpreted to be due to enhanced salt flushing under the topography low due to depression focused recharge. The temperature correction on the data and the time-lapse inversion has reduced some of the noise present in figure.
